SMITH RESERVOIR DAM  
ERIE COUNTY, COMMONWEALTH OF PENNSYLVANIA  
NDI No. PA 00017  
PennDER No. 25-28

PHASE I INSPECTION REPORT  
NATIONAL DAM SAFETY PROGRAM

Smith Reservoir Dam, Erie County, Pennsylvania  
NDI No. PA 00017, PennDER No. 25-28  
West Branch of Sixteen Mile Creek  
Inspected 12 May 1980

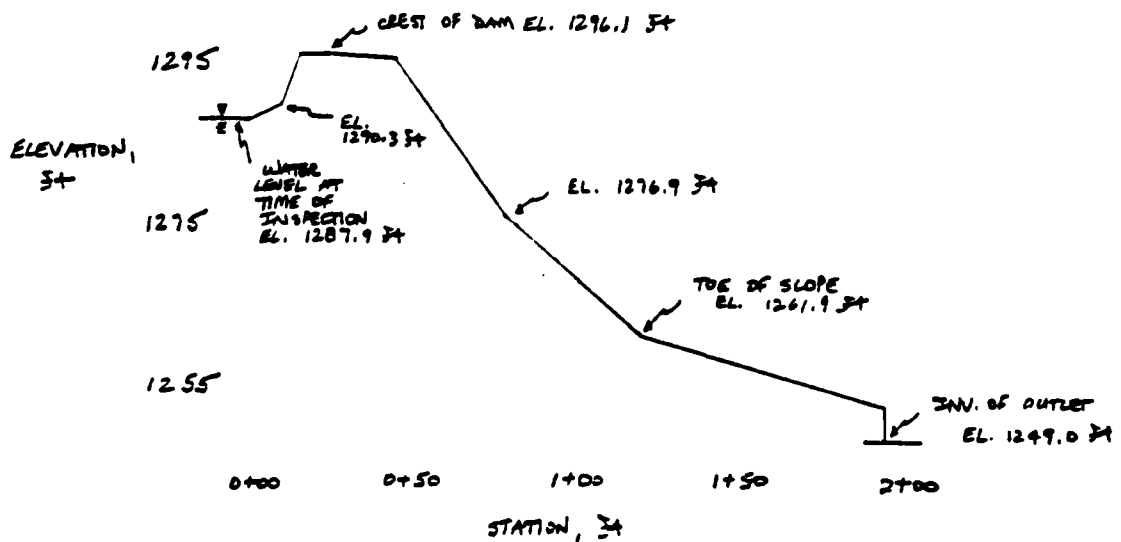
CROSS-SECTION AT STATION 2+50

- c. Visual Observation - At the time of the inspection, no conditions were observed which would seriously affect the functioning of the spillway or dam during a flood event. There is one low spot on the dam crest (Station 2+50) which is approximately 0.2 foot below the average crest elevation.
